Advanced Techniques of Stained Glass Conservation

Conservation Report for the Conservation Project on panel: 883040681.4, Head panel St. George

Panel Number: 88304681.4

Title: Head panel for St. George from light C, window E1.

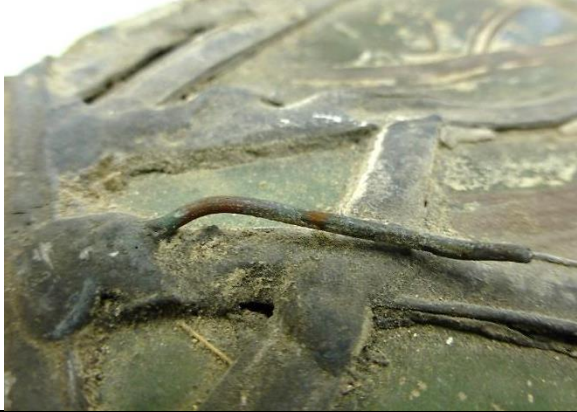
1 - Copper tie on the right side	2 - Copper tie in the centre

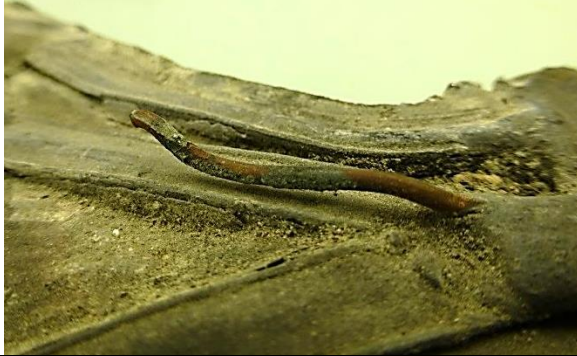
3 - Copper tie on the left side	4 - Topmost broken lead at the apex

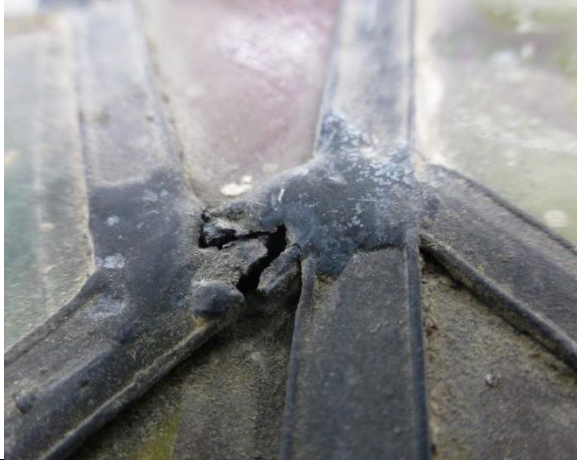
5 - Torn lead in the centre of the panel	6 - Small area of missing lead

Re-soldering broken joints: The old solder joints will first be cleaned, in order to make the heat transfer quicker. This will minimise the risk to surrounding glass and lead which may be exposed to the heat. Solder will then be applied to seal the break.

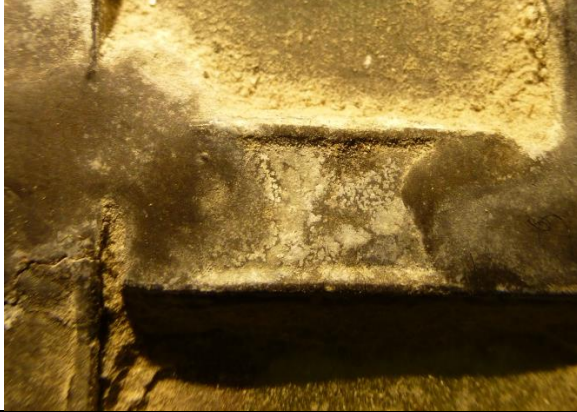
7 - Lead oxidation	8 - Surface soiling - putty

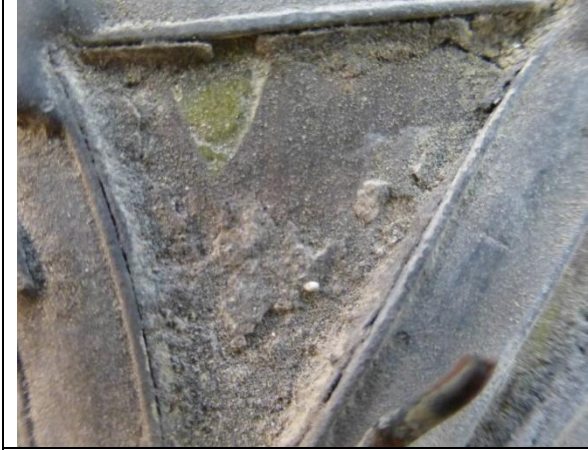
11 - Heavy surface soiling and flaking corrosion crusts	12 - Deep pitting, cracks, chipped glass and damaged lead

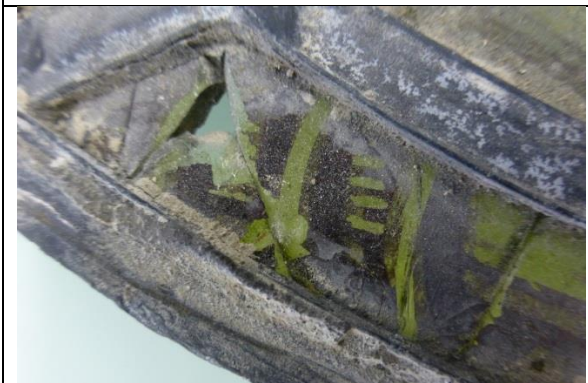
There are around twenty-one breaks across the whole of the panel; one piece in particular has numerous breaks. This piece is on the edge, and the cracks are close together, some of them do not continue through the whole of the piece. This damage is most likely caused by pressure, with it being a piece at the edge, and unlikely to be due to impact or vandalism.

13 - Heavily fractured piece of glass, with a small missing area.	14 - Mechanical damage on the glass (scratches), where pitting is developing

Securing cracks: I will clean the cracks with acetone, cotton swabs and un-waxed dental floss. Then use Araldite to bond the edges of the break together.

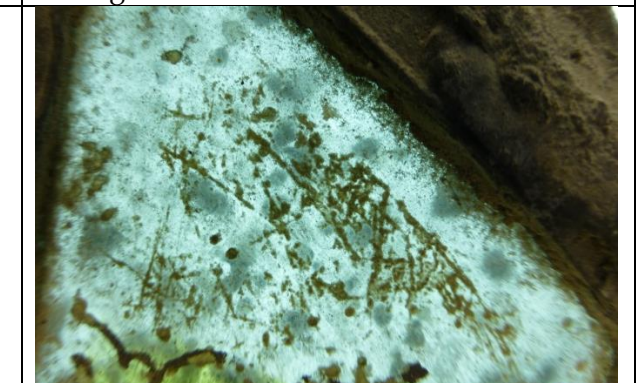
There is some mechanical damage, in the form of scratches on both sides of the glass and this may have been caused by harsh cleaning from an earlier date.

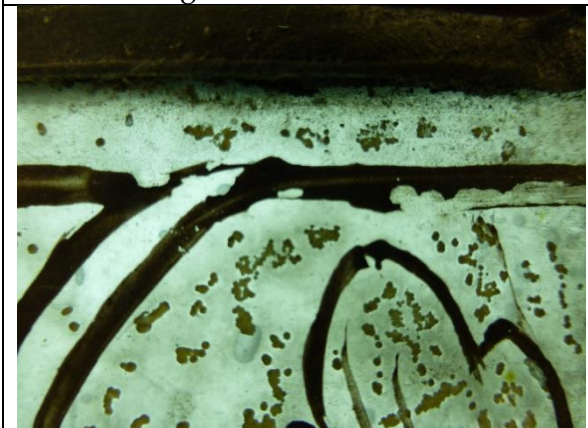
15 - Paint loss	16 - Severe paint loss

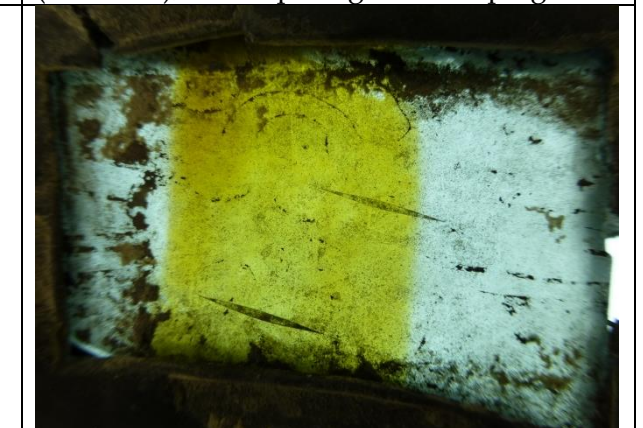
Paint layers: The paint has suffered partial loss in several places across the panel, almost always in the fourteenth century pieces. There is major loss in two medieval infills, where only ghost lines are visible. These pieces are likely to be from an entirely different source due to the fact that the majority of the other paint remains and seems to be in a stable condition. Some paint loss is difficult to detect due to the appearance of a corrosion crust across the surface, but in general the paint prevents against pitting, so is not lost in this way. Some of the yellow stain on the reverse of the panel has been damaged, due to pitting which appears in it. There are pits distributed across the surface of the yellow stain causing the colour to break up in appearance (see pages 13 and 14).

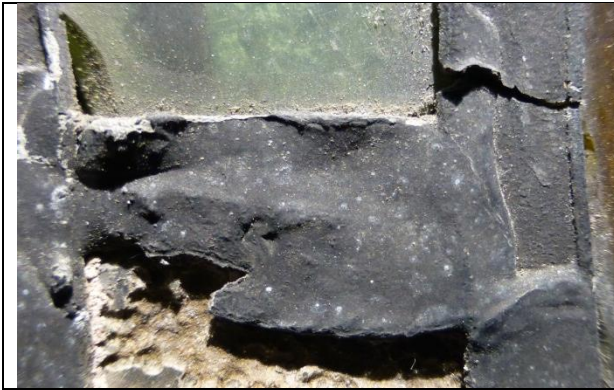
17 - Strap lead

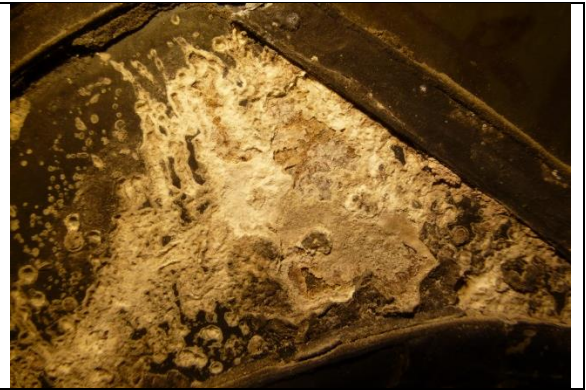
18 - Severe corrosion

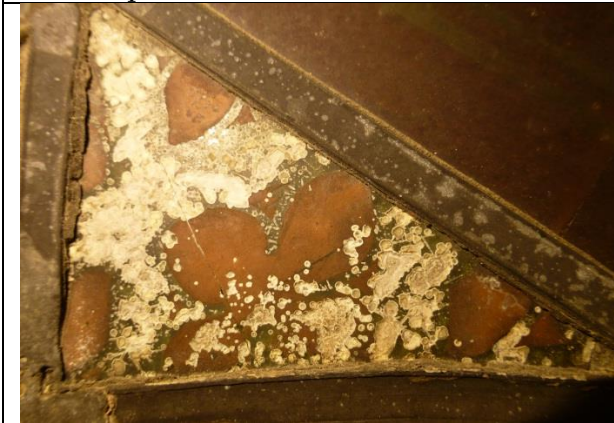
The inverted piece has a significant amount of corrosion compared to the other pieces, yet it is unclear whether the paint has disappeared or not, due to the amount of dark corrosion crusts which are in place. Pitting also occurs on this piece.

19 - Inverted piece, heavily corroded

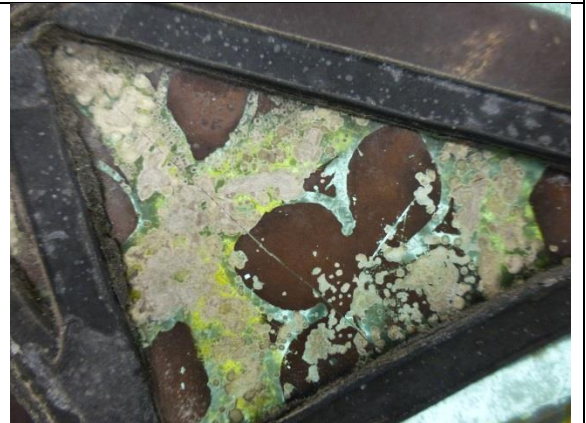
20 - Inverted piece with transmitted light

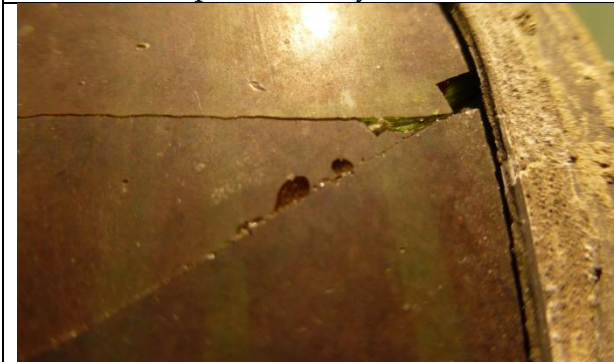
21 - Cracked and chipped glass

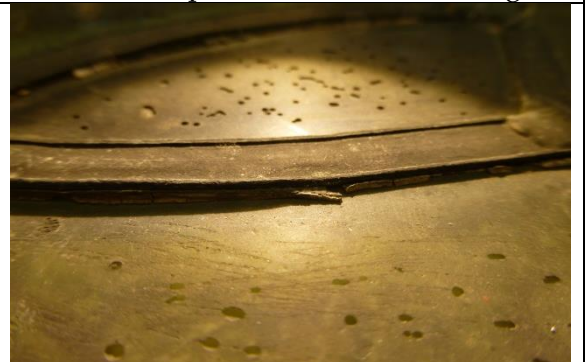
22 - Failing putty

Re-puttying: I intend to re-putty on the back so that the putty does not get into the corrosion or paint layers.

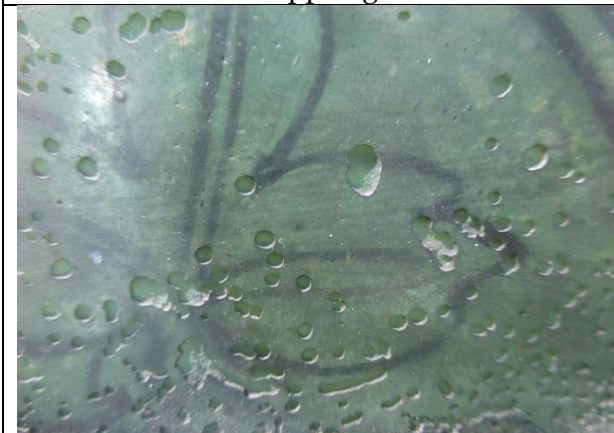
23 - Deep pitting

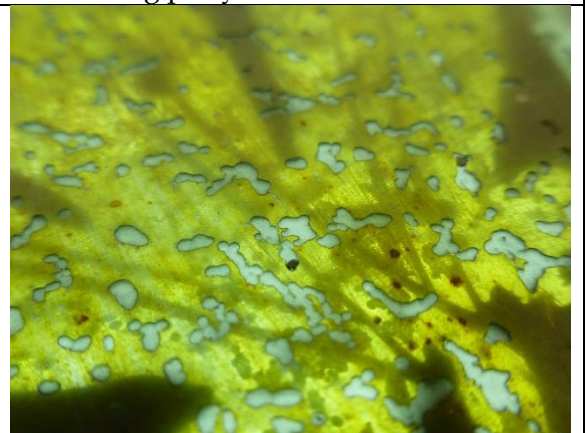
24 - Pitting and mechanical damage (scratches) on yellow stain

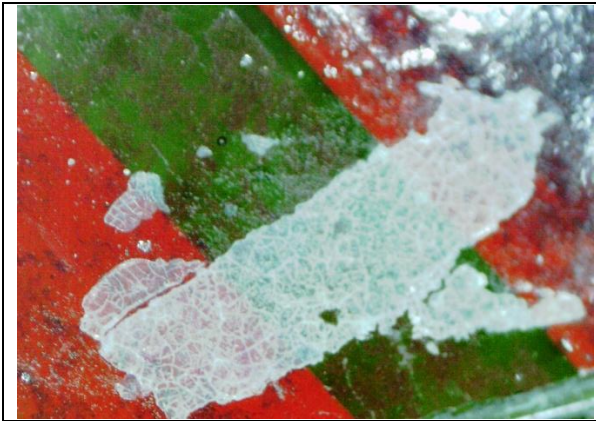
<p>1 - Sticky residue (x1 zoom)</p>	<p>2 - Chipped glass</p>

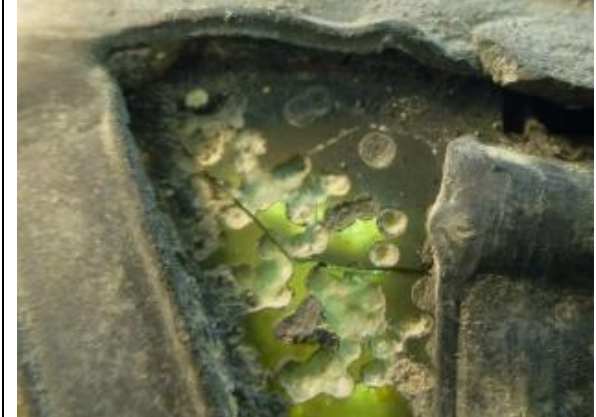
<p>3 - Crack</p>	<p>4 -Missing glass/ glass cut too small</p>

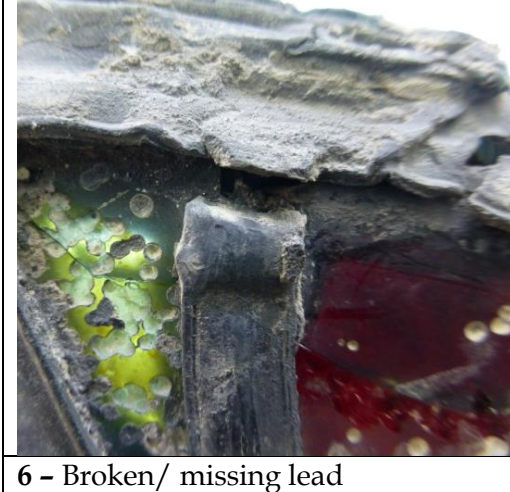
<p>6 - Broken/ missing lead</p>
