Advanced Techniques of Stained Glass Conservation

Conservation Report for the Conservation Project on panel: 883040681.4, Head panel St. George

Panel Number: 88304681.4

Title: Head panel for St. George from light C, window E1.

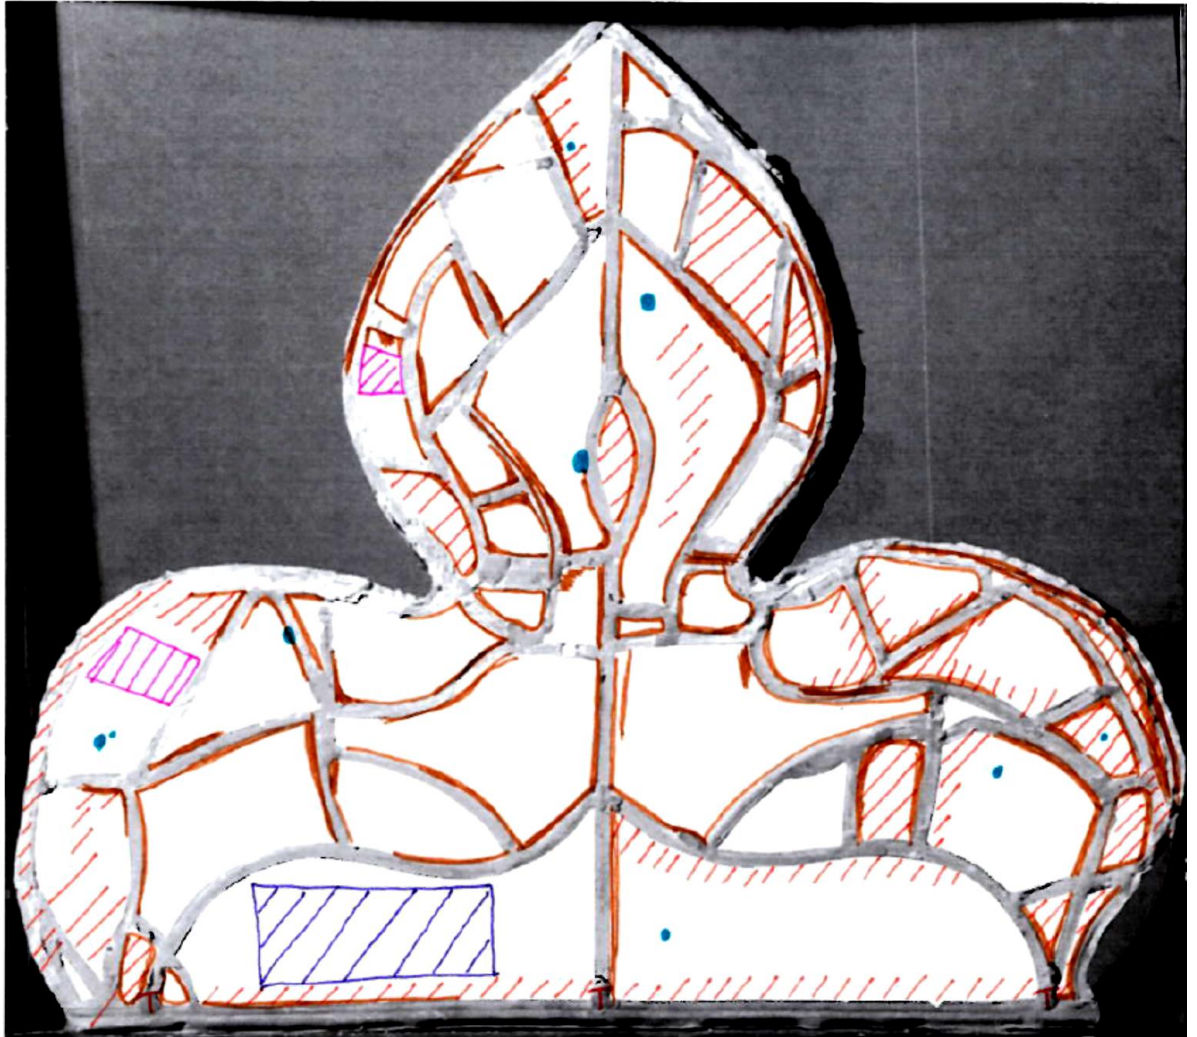
Surface accretions on the glass and lead (interior)

Across the panel we find general soiling which has accumulated from years of settling dust, and condensation. Around the edges of most of the pieces of glass, there is dried putty, most likely caused by seepage. There are eight small mortar splashes. Toward the left of the panel in two places residue from adhesive tape can be found; which give the glass a light, shiny appearance. Across the bottom left of the panel is a sizeable label detailing the location of the panel, when it occupied the east window. This label is a generic adhesive labelling sticker, the mapping for surface accretions can be found on page 10.

Removing excess putty and other dirt: Mortar, putty etc. will be removed from the surface of the glass using a brushes and a scalpel, under a microscope. Where any bonds between the dirt and the glass are too great ethanol and water will be used to loosen them. Acetone will be used if the ethanol solution does not work.

Removal of the adhesive label: A fume chamber will be made by placing a piece of cotton wool soaked in acetone in a resistant container, and placed next to the adhesive label. A box or air tight container e.g. upside down Tupperware, will be placed over the top of the label and the cotton wool. The fumes will be trapped inside the space and after some time the adhesive bonds should loosen. The fumes will be left to develop for 30minutes, then their effect on the adhesion of the label will be analysed every fifteen minutes.

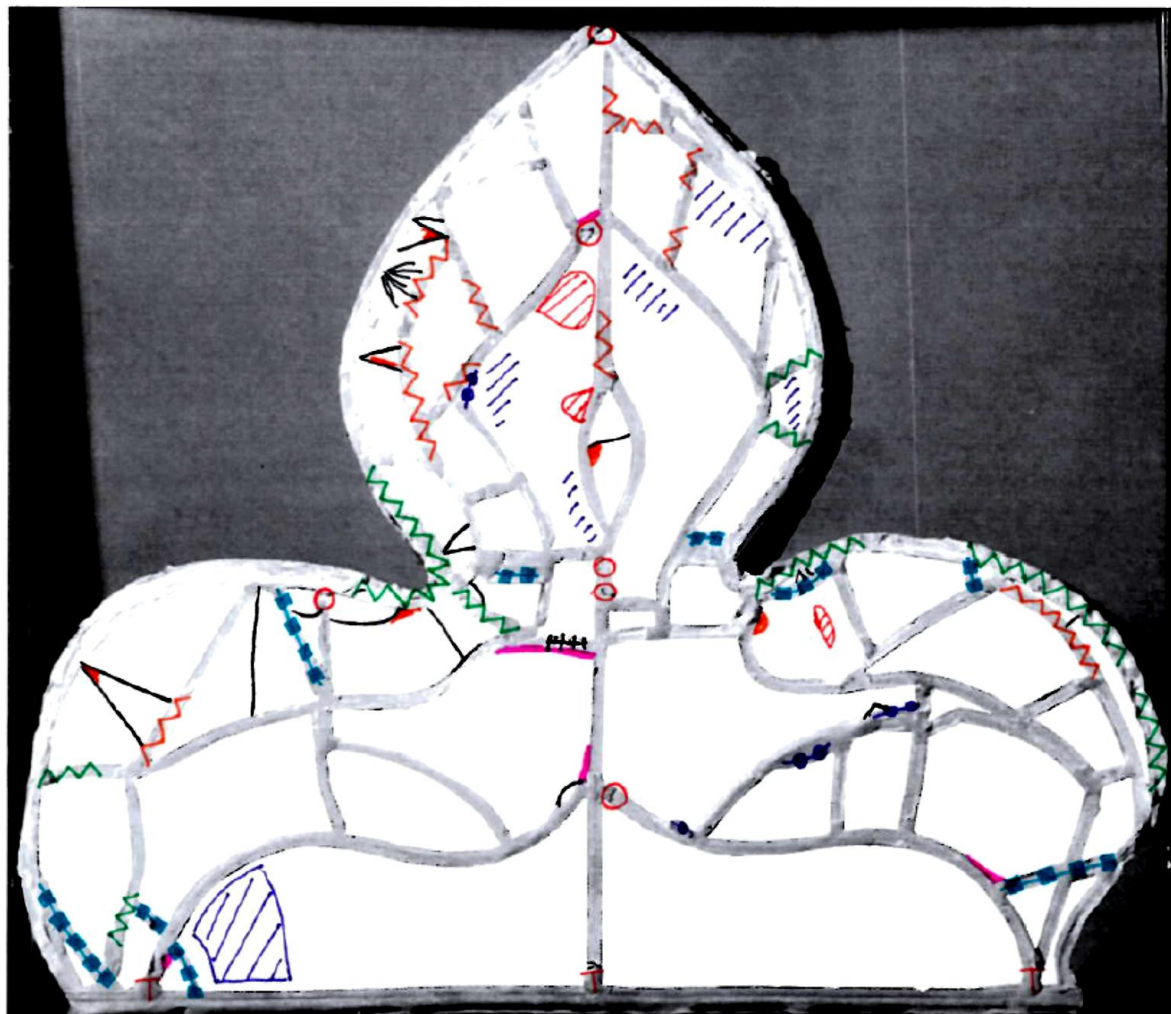
Damage/condition of the glass and lead (interior)

The panel is not in a stable condition, and requires a great deal of care and professional experience to move it. This is due to broken leads and failing putty.

Lead: The lead net itself is strong and in good condition although there are six breaks occurring at or near solder joints along the centre of the panel, which are weak points in the network. Throughout the panel there is failing putty/cement which makes the panel fragile. It is visible beneath the lead, in a dry and crumbling state. Vertically through the centre of the panel there are a number of breaks and the putty has failed completely, which means the panel is liable to separate down the middle (see condition mapping on page 11).

There are around twenty-one breaks across the whole of the panel; one piece in particular has numerous breaks. This piece is on the edge, and the cracks are close together, some of them do not continue through the whole of the piece. This damage is most likely caused by pressure, with it being a piece at the edge, and unlikely to be due to impact or vandalism.

The damage may even have occurred during de-installation, due to the fact that the cracks, which only reach part way across the piece of glass, are very clean. None of the breaks appear to have been mended with anything, i.e. resins or animal glues. There is a lot of chipped glass, which mostly occurs where there are breaks, or at corners. Due to the re-leading and the excessive use of infills not originally destined for this panel, there is evidence of the glass pieces not fitting properly in the lead-net. In some cases attempts have been made to groze the edges, but where the putty has failed, gaps are clearly visible (see page 11).

Re-soldering broken joints: The old solder joints will first be cleaned, in order to make the heat transfer quicker. This will minimise the risk to surrounding glass and lead which may be exposed to the heat. Solder will then be applied to seal the break.

Strap lead over the missing lead: A strap lead will be applied to the front and back of the missing area of lead, using as close to the same size and profile of lead. It will be soldered in place.

Securing cracks: I will clean the cracks with acetone, cotton swabs and un-waxed dental floss. Then use Araldite to bond the edges of the break together.

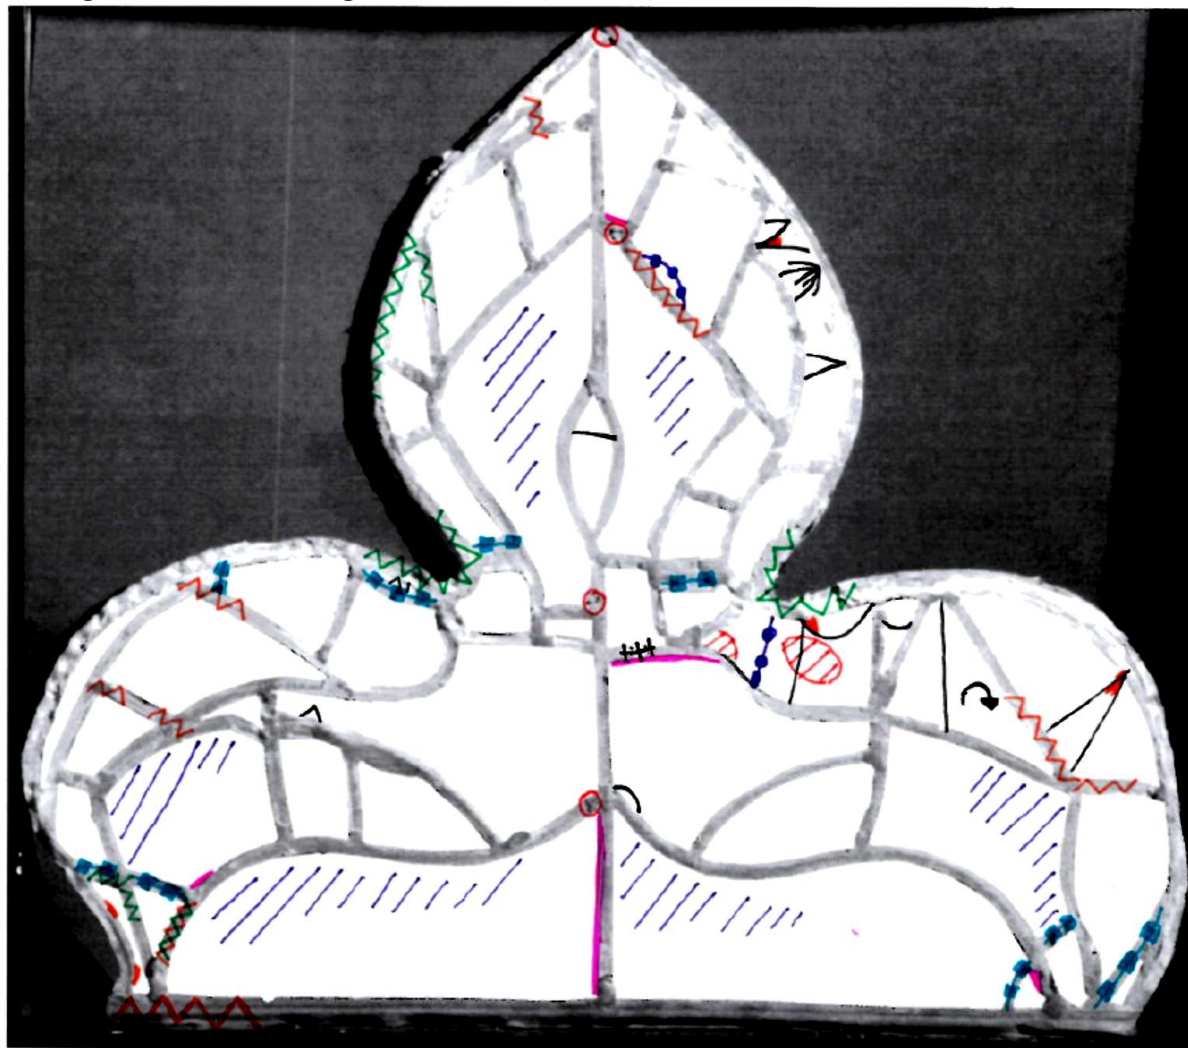
Damage/condition of the glass and lead (exterior)

There is a severe amount of pitting covering the majority of the panel; however more occurs on the outside than the inside. The nineteenth century glass does not show signs of pitting, whereas most of the fourteenth century glass does. In some cases it is evident that the pitting has erupted along the scratches caused by earlier mechanical damage. The paint seems to prevent the pitting. On the reverse however, pitting often occurs on the yellow-stained areas, sometimes avoiding the areas which have not been stained. In all cases the pits are filled with dirt and are white. There are some corrosion crusts which are all in a developed stage. There is also evidence of missing layers of glass, which are likely to have been corrosion crusts which have flaked off. There is a couple of instances where the flash layer has detached, and two instances where the surface of the glass is uneven, and has a chipped texture, but this does not affect the painted areas or instigate corrosion and is likely to be a production default rather than damage occurring later (see pages 15 and 16).

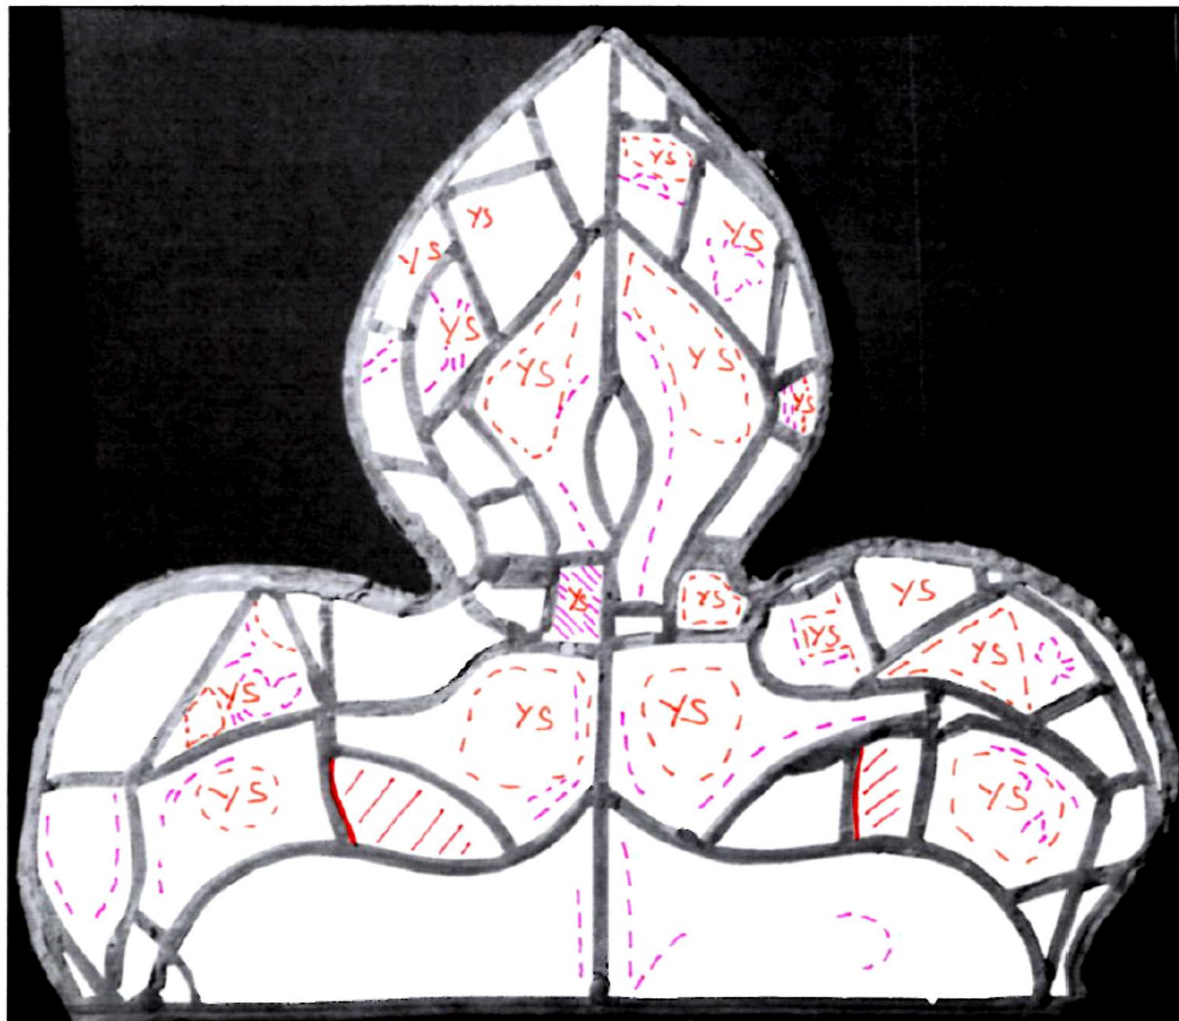
Condition and damage of paint layers (interior)

Paint layers: The paint has suffered partial loss in several places across the panel, almost always in the fourteenth century pieces. There is major loss in two medieval infills, where only ghost lines are visible. These pieces are likely to be from an entirely different source due to the fact that the majority of the other paint remains and seems to be in a stable condition. Some paint loss is difficult to detect due to the appearance of a corrosion crust across the surface, but in general the paint prevents against pitting, so is not lost in this way. Some of the yellow stain on the reverse of the panel has been damaged, due to pitting which appears in it. There are pits distributed across the surface of the yellow stain causing the colour to break up in appearance (see pages 13 and 14).

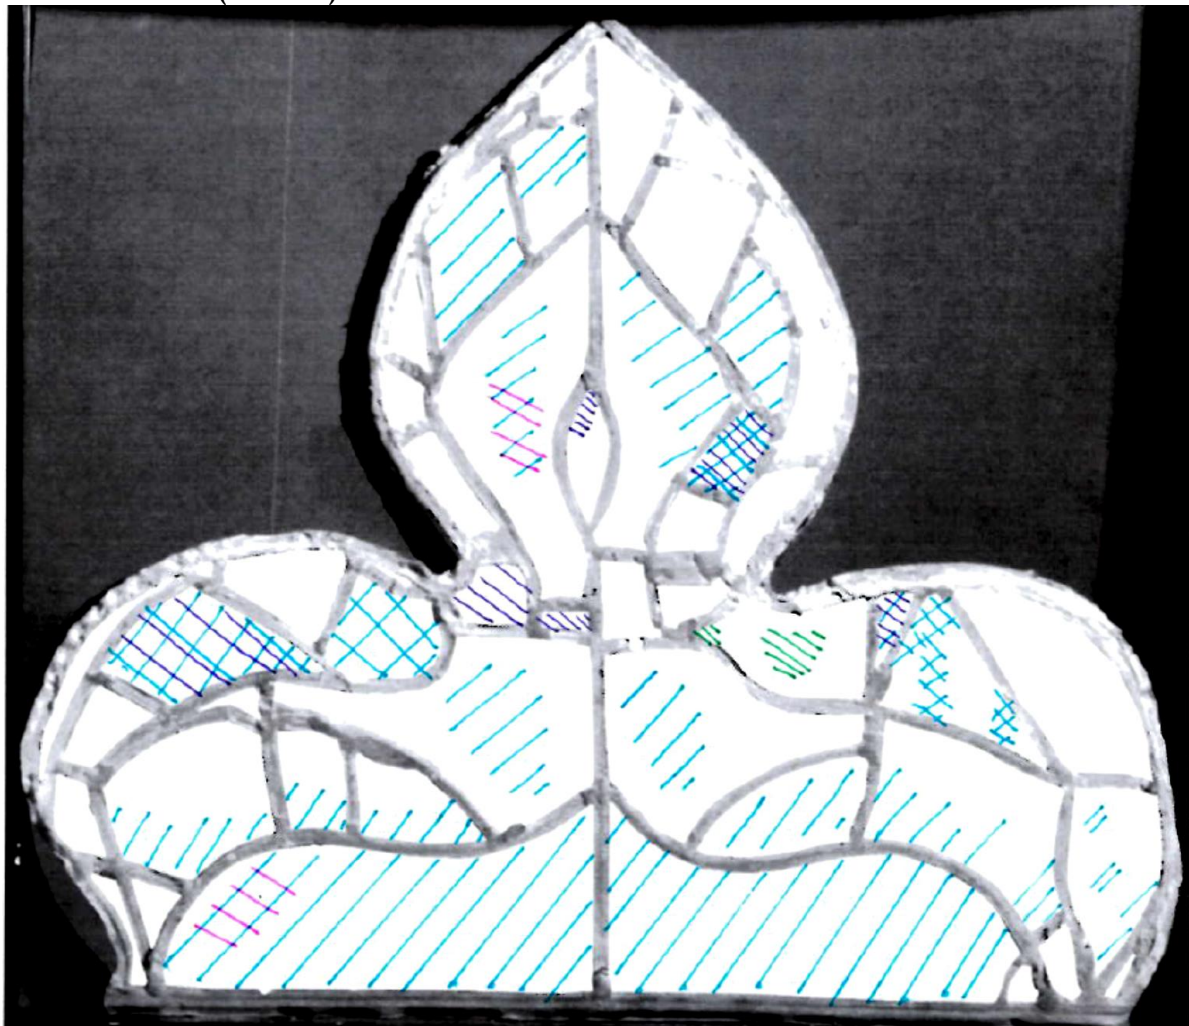
Glass corrosion (exterior)

The inverted piece has a significant amount of corrosion compared to the other pieces, yet it is unclear whether the paint has disappeared or not, due to the amount of dark corrosion crusts which are in place. Pitting also occurs on this piece.

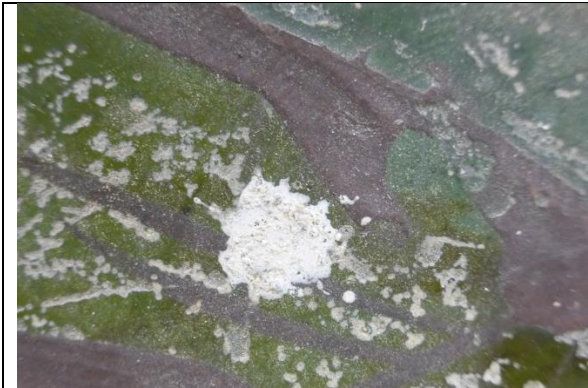
9 - Surface soiling - mortar splashes	10 - Surface soiling - sticky label

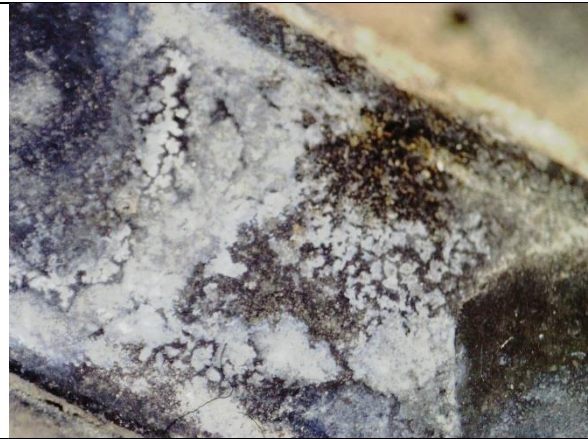
There are some white deposits on the lead in areas, which may be caused by oxidisation but this is not clear, without further laboratory testing. There is no major corrosion. Some damage has occurred on the leads, such as small cuts which have folded back on themselves. These cuts do not carry all the way through. On one occasion the lead has been damaged by something scraping across it and gouging a chunk out. This damage could have occurred during the de-installation, because the exposed lead looks shiny and silver which indicates it has not been exposed to the atmosphere for a long time, and is likely to be a relatively fresh incident.

a - Lead oxidation x1	b - Surface soiling - putty x1

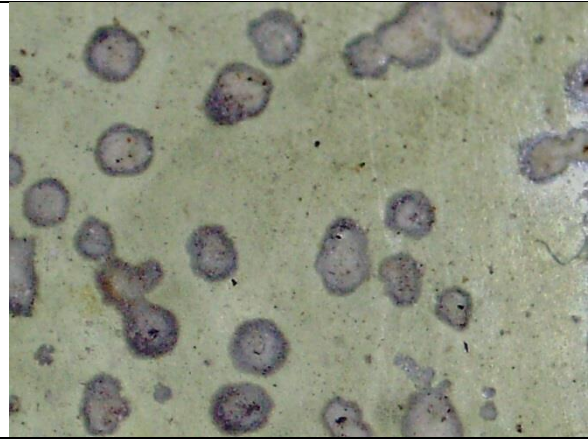
c - Light pitting x3	d - Heavy pitting x3

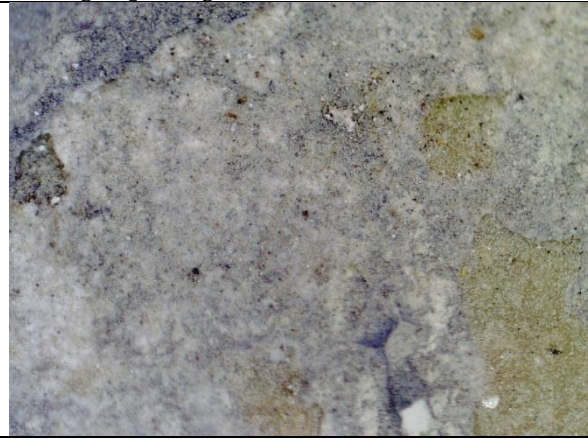
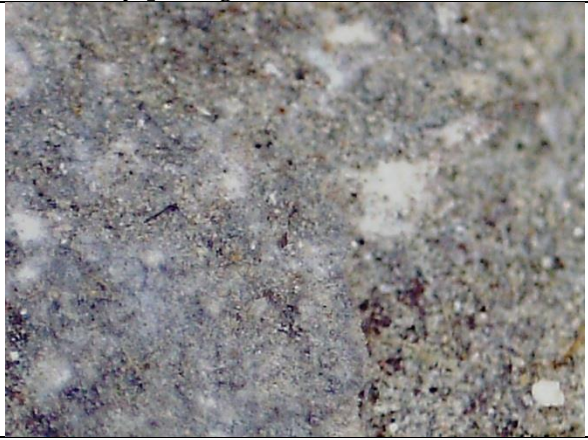
e - Corrosion crusts x1	f - Corrosion crusts x4

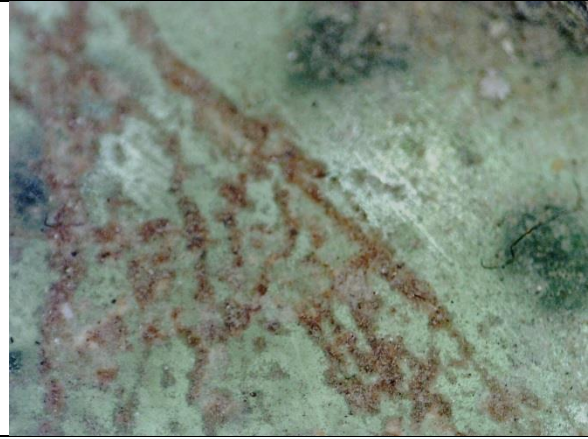
There is some mechanical damage, in the form of scratches on both sides of the glass and this may have been caused by harsh cleaning from an earlier date.

g - Mechanical Damage x1	h - Paint loss x1

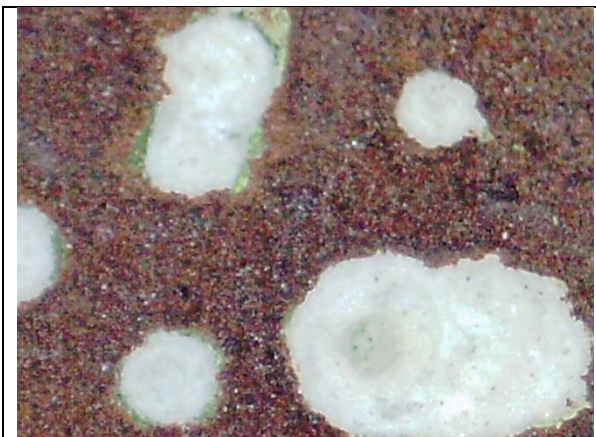
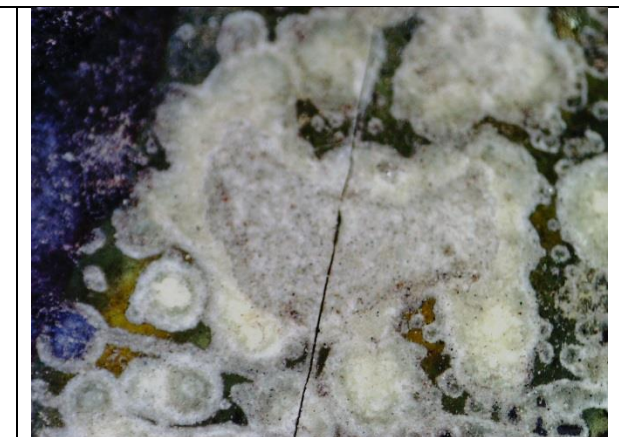
<p>i - Inverted piece with paint and pitting x3</p>	<p>k - Inverted piece without paint, with pitting x1</p>

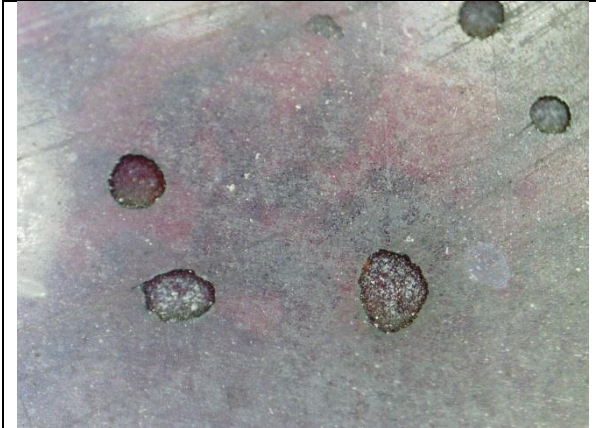
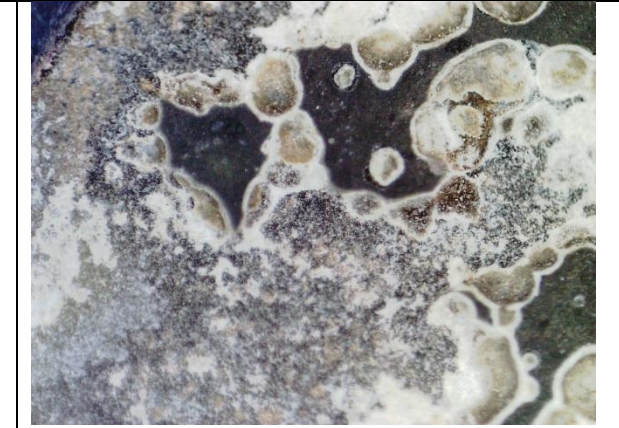
<p>l - Mild pitting x1</p>	<p>m - Heavy pitting x1</p>

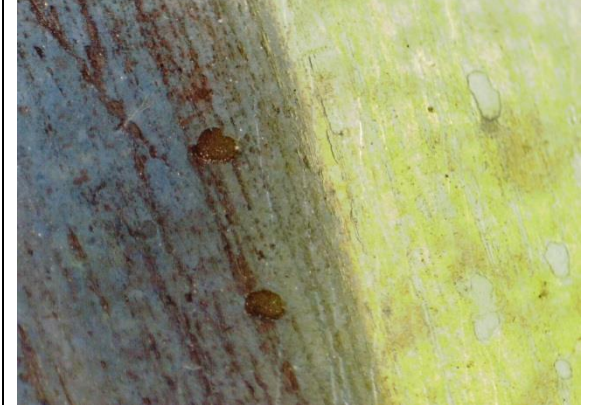
<p>n - Mechanical damage (scratches) x1</p>	<p>o - Yellow stain with deep pitting x3</p>

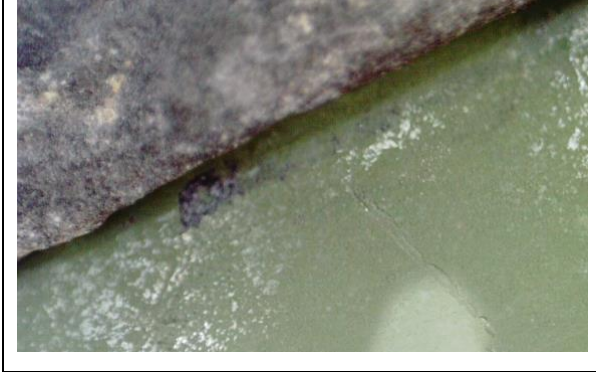
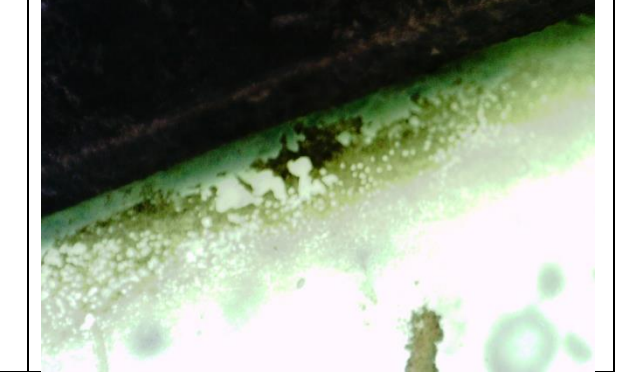
<p>5 - Paint</p>	<p>7 - Paint (x1 zoom)</p>

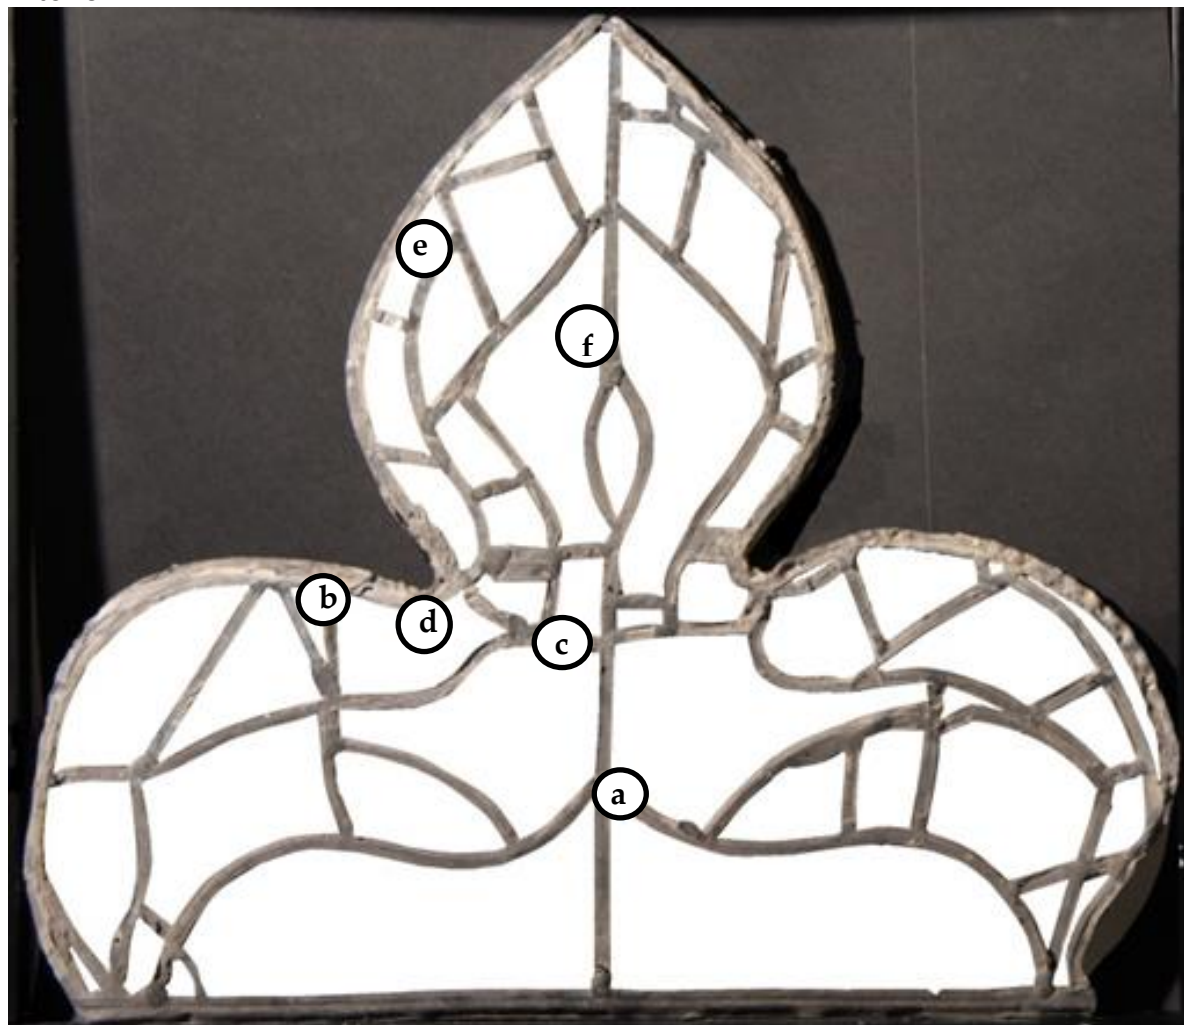
a	Solder joint	b	Solder joint
c	Strap lead	d	Araldite infill
e	Araldite infill	f	Re-puttying (on exterior)

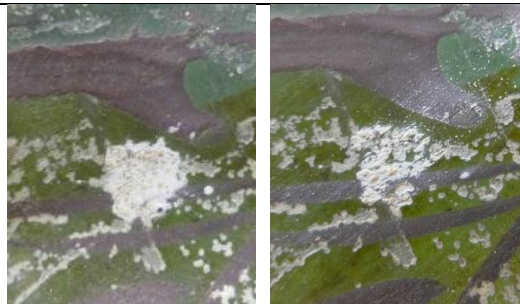
Results			
<p>The mortar splashes were difficult to remove with soft brushes. Some of the mortar came off with a rougher brush but not a significant amount.</p> <p>More trials will be carried out on them.</p>			<p>(5) Mortar splash before and after cleaning with brushes. Some, but not all layers of the dirt have been removed.</p>

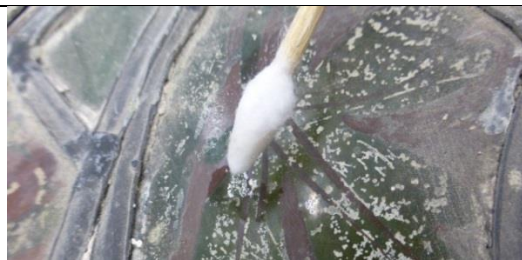
Results			(5) The mortar splash completely removed.
Mortar splashes were completely removed with deionised water. This is a safe option where the mortar cannot be removed through mechanical methods. Ethanol was not needed.

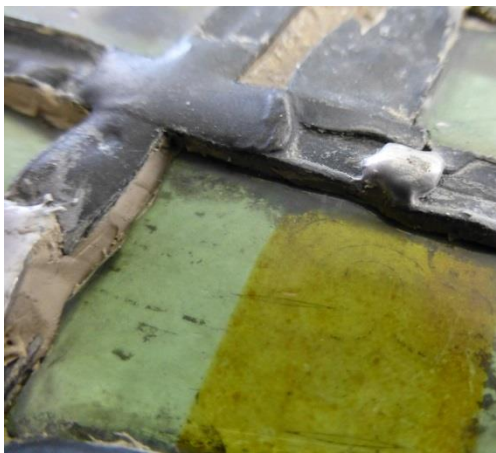
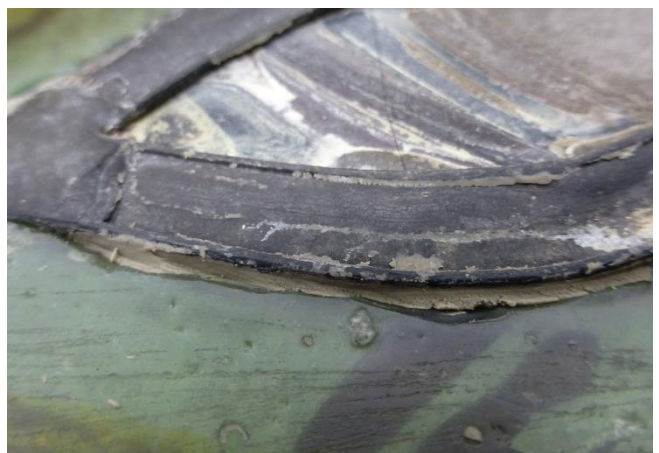
The application of the putty was quite difficult because the lead was rough and oxidised. Furthermore extra care must be taken when applying putty to areas where the glass has corrosion on. One area had to be left because the corrosion crusts were so severe.

The panel was re-puttied on the back in the areas labelled on the intervention mapping diagrams. Only the central areas of the panel were re-puttied where the existing putty had failed and fallen out. The putty used was soft glazier's putty.

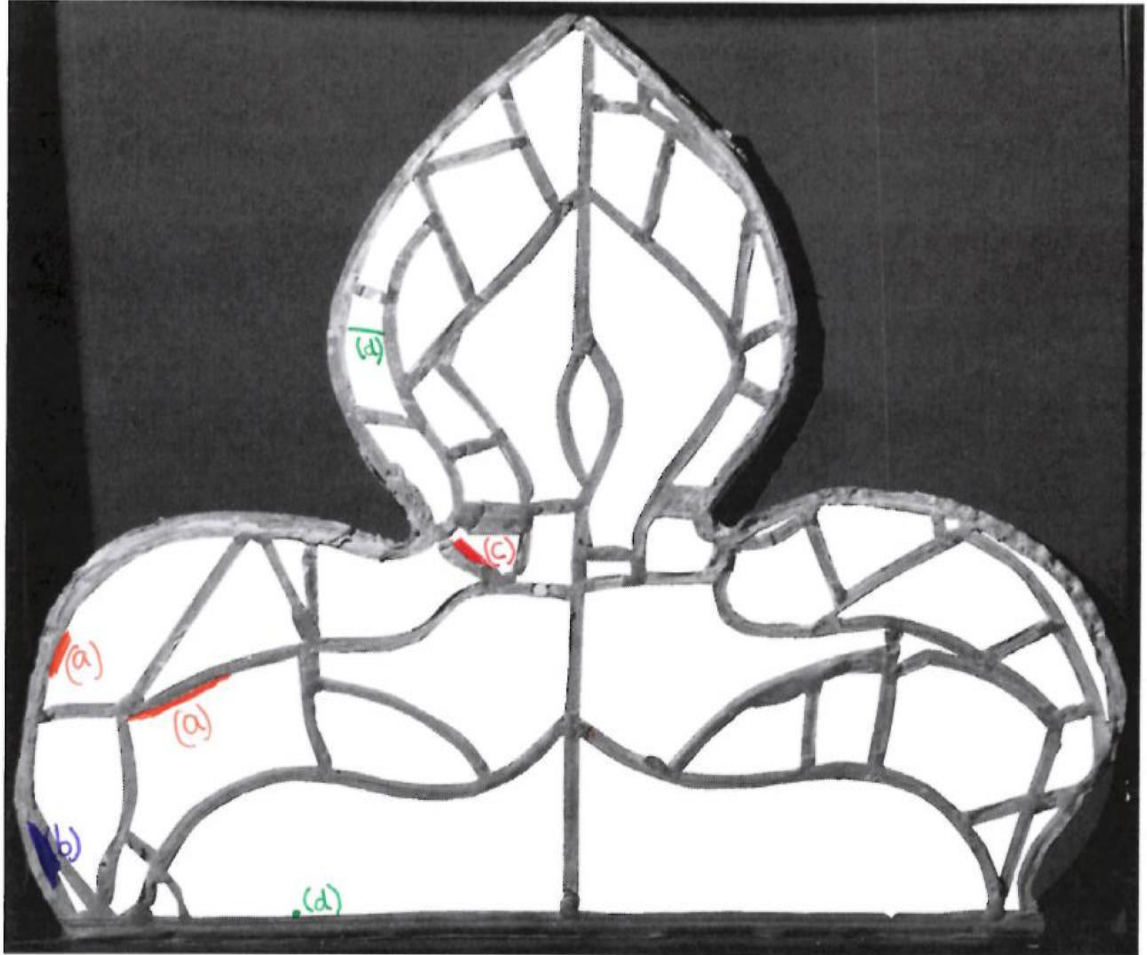
Samples of putty and mortar, which were removed from the panel during cleaning, were saved for future reference, and will be given to the client upon completion of the project for them to file and keep as they feel necessary. A small piece of dry, damaged lead and some small glass shards, which had paint on them, and separated from a crack in the glass during cleaning, were also saved. A further piece of glass was also found in the bottom lead but it is unclear where this has come from because there is no evidence of missing glass nearby. These have all been saved and the locations of which are detailed below.

Sample type from the panel	Symbol
Putty	— (a)
Mortar	— (b)
Lead	— (c)
Glass shards	— (d)
